Inspection Report

Property Address:
5630 Ostrom Ave.

Della Mandell Residence

20/20 Vision Home Inspections, LLC

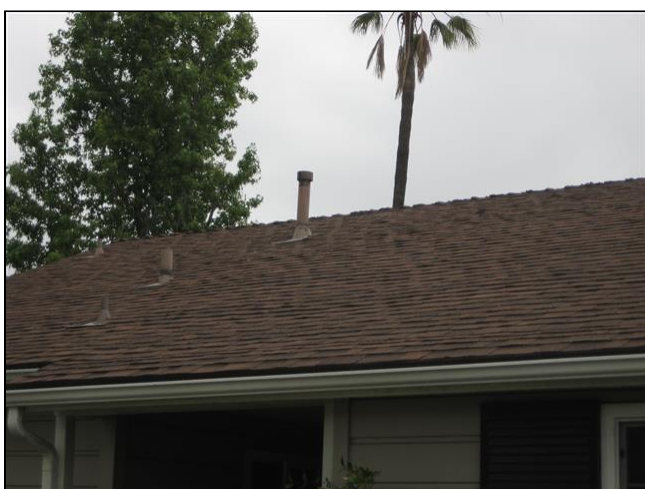
1.0 Item 1(Picture) Front of main roof

(2) The roof covering is nearing the end of its life cycle and has more than one existing layers of roof covering at the "entire roof" and unattached garage. Roof covering will need replacing within 1 to 5 years. Existing roof covering must be removed prior to installation of new roof covering. Also, there is immediate repair needed to replace the ridge caps. A qualified licensed roofing contractor should further inspect and repair or replace as needed.

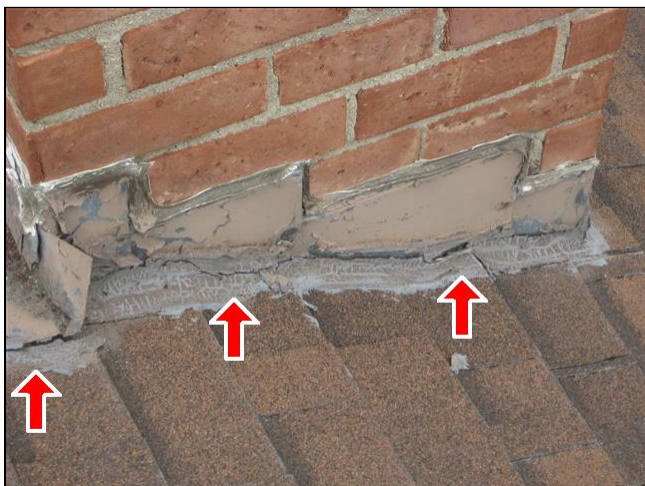
1.1 Item 1(Picture)

1.1 Signs of a prior leak at chimney flashing evidenced by appearance of handy man tar repairs at roof to chimney connection. The repair is not functional and needs further evaluation and repair by licensed roofing contractor.

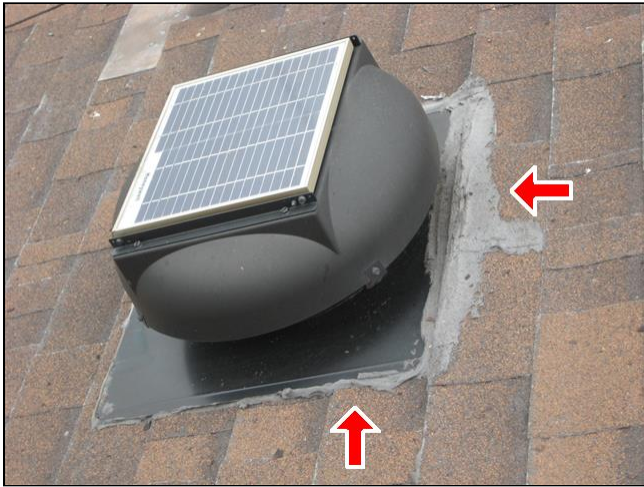
1.2 Item 1(Picture) Solar Powered motorized roof vent

Motorized roof vent installed to reduce temperature in adequately vented attic. Improper installation of flashing. Recommend further evaluation and repair by licensed roofing contractor.

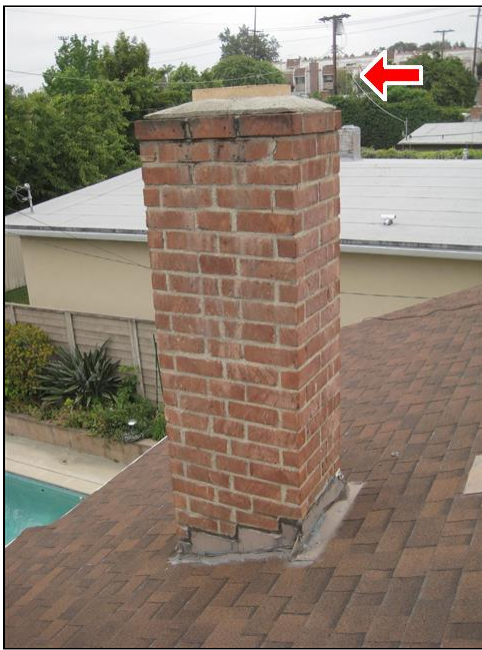
1.2 Item 3(Picture) Missing spark arrestor

Spark arrester is missing or damaged. Recommend further evaluation and repairs by licensed chimney contractor. This item is a safety hazard.

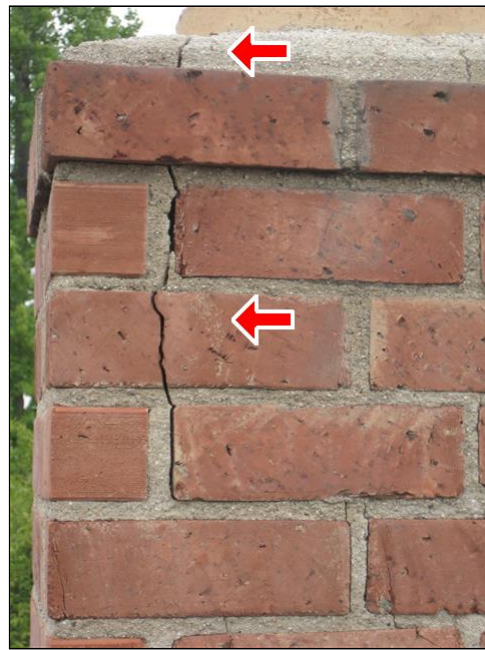
1.2 Item 4(Picture) Damaged Chimney

Structural cracking in brick chimney. Safety hazard. Recommend further evaluation and repair by licensed chimney contractor.

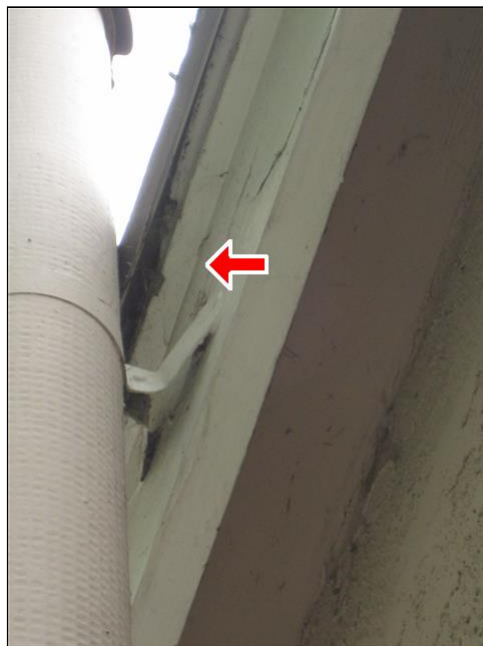
1.2 Item 6(Picture) Separation Recommendation

Recommend separation between roof edge and hot water heater vent stack.

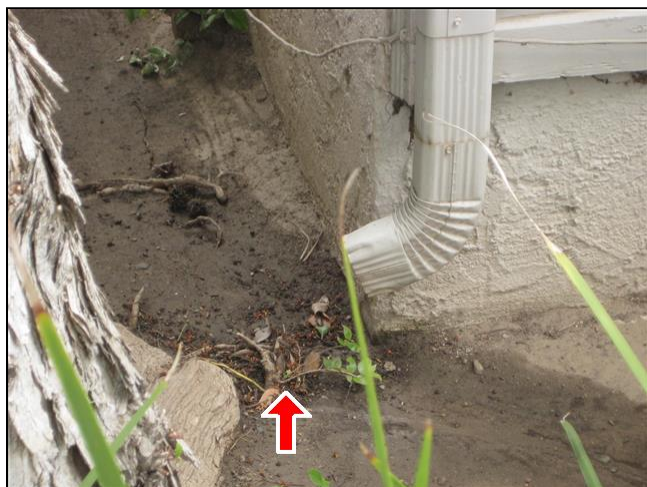
1.3 Item 1(Picture) Gutter Elbow

1.3 (1) Gutter need extension or splash block to channel water away from foundation. This is a minor repair that can help prevent water from effecting foundation.

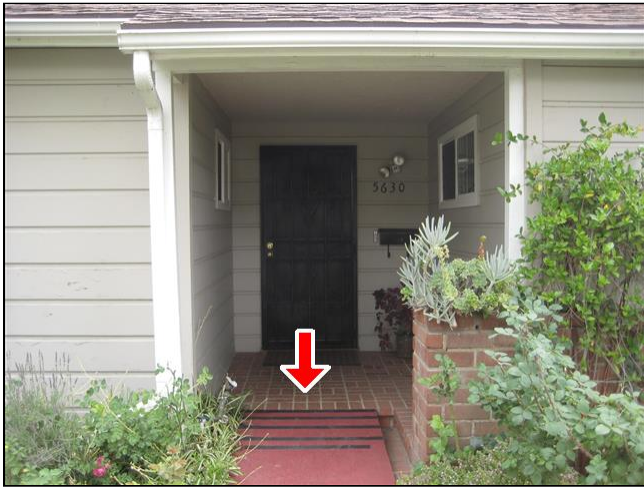
2.3 Item 1(Picture) Removable ramp

2.3 Homeowner installed removable ramp at front entry. Recommend checking ADA standards to verify safety.

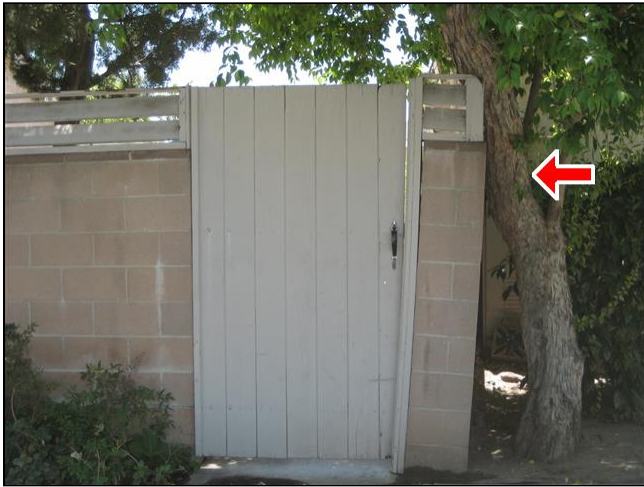
2.4 Item 1(Picture) Leaning wall

The block wall at north side of home is crack and leaning. Safety hazard. Recommend further evaluation by structural engineer.

The retaining wall near south side of swimming pool is leaning and moving off foundation. Furthermore no weep holes are present for water drainage. Recommend further evaluation by structural engineer.

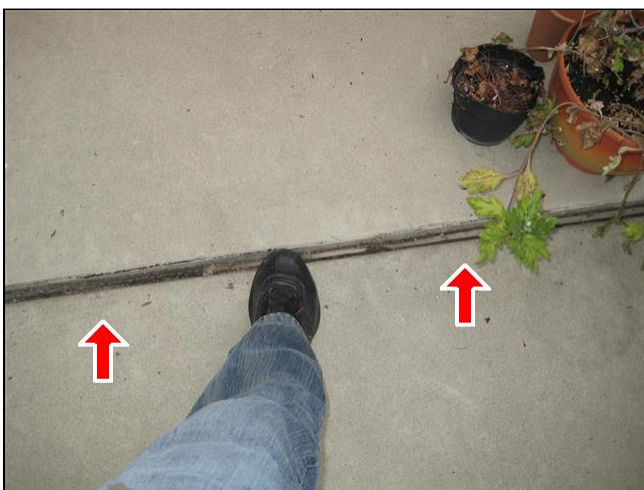
2.4 Item 5(Picture) Trip Hazard

Severe cracking was found throughout patio concrete surfaces. Additionally sections have risen to unsafe level. Safety hazard as bare feet can be injured and trip hazard present. Recommend further evaluation and repair by licensed concrete contractor.

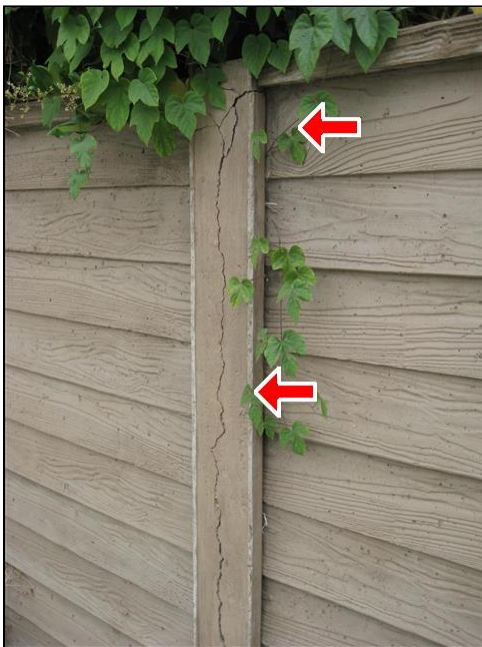
2.4 Item 9(Picture) Structural cracking at property demising wall

Severe cracks were found in the the structural posts of the property demising wall. Recommend further evaluation by structural engineer.

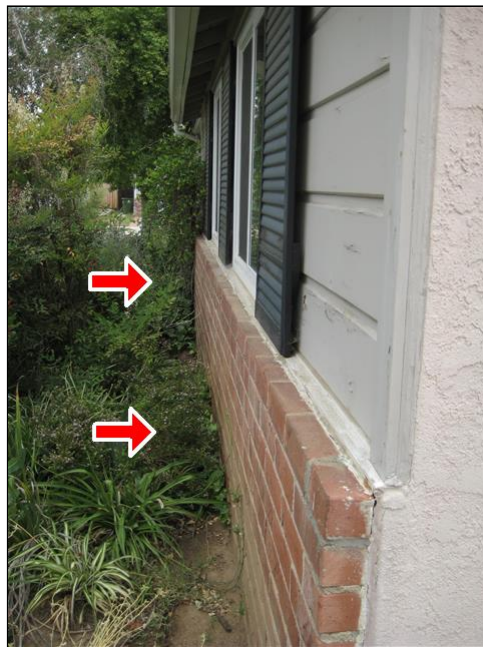
2.4 Item 10(Picture) Close vegetation

In some areas on the exterior of the home vegetation is close or touching the home. It is always a good idea to keep separation between the home, foundation and vegetation. Watering of vegetation and roots have the potential to damage the foundation over time.

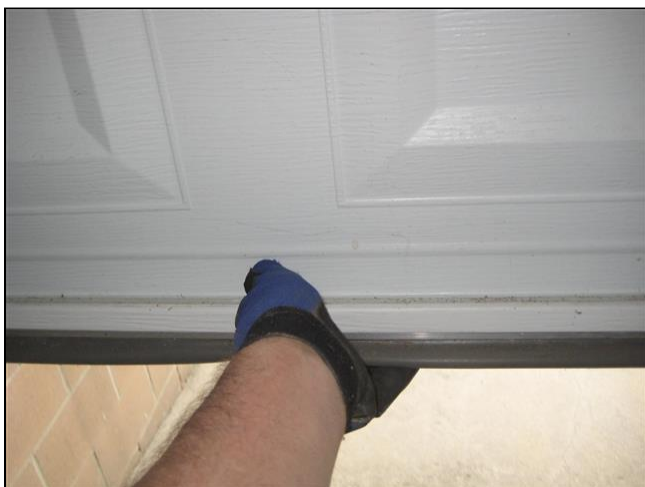
3.3 Item 1(Picture) Safety Issue

3.3 (1) The garage door of detached building at the (East side of home) will not reverse when met with resistance. Doors that will not reverse when met with resistance can kill a child or pet. A qualified contractor should inspect and repair as needed.

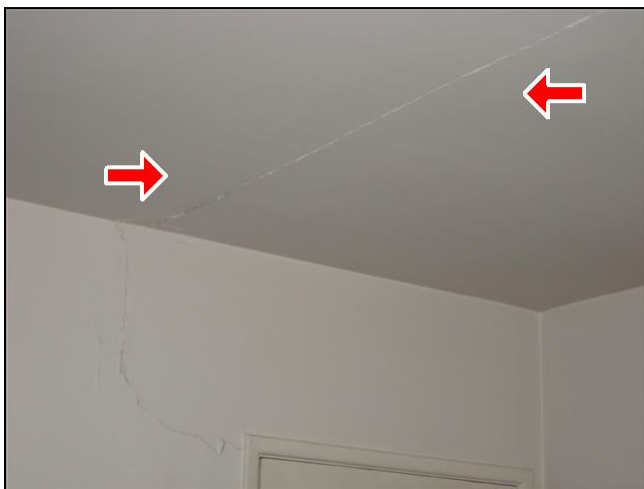
4.0 Item 1(Picture) Ceiling cracks

(2) The Plaster on the ceiling has multiple cracks at the through entire home. While this damage is cosmetic, it should be repaired. A qualified person should repair or replace as needed.

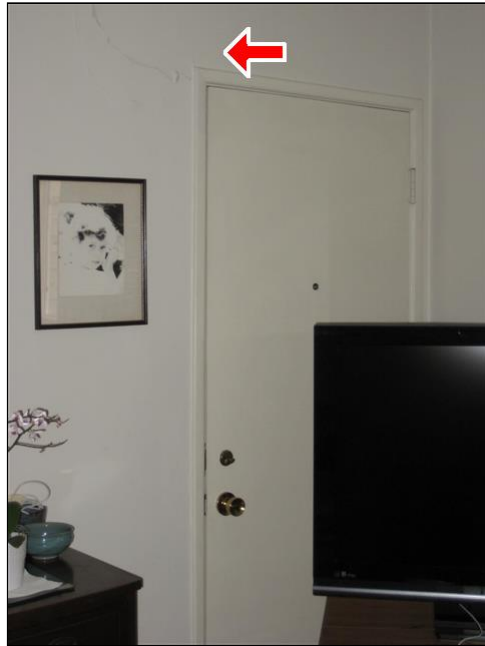
4.1 Item 2(Picture) Wall cracks

(2) The plaster on the wall shows evidence of cracking at the in several rooms particularly near doors. While this damage is cosmetic, it should be repaired. A qualified person should repair or replace as needed.

Homeowner stated this damage was caused by 1994 earthquake and has not gotten worse since. Advise to further monitor for changes. Wall coverings prevented inspection of structural members.

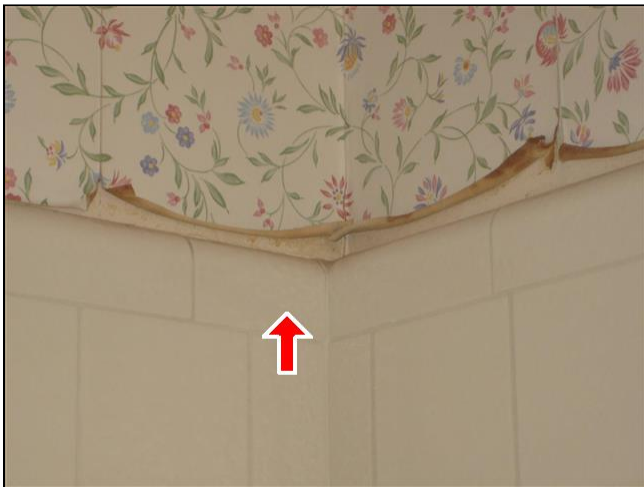
4.1 Item 3(Picture) Peeling wall paper

(3) The wall paper on the wall is peeling in areas at the master bath. This damage is considered cosmetic. This is simply for your information..

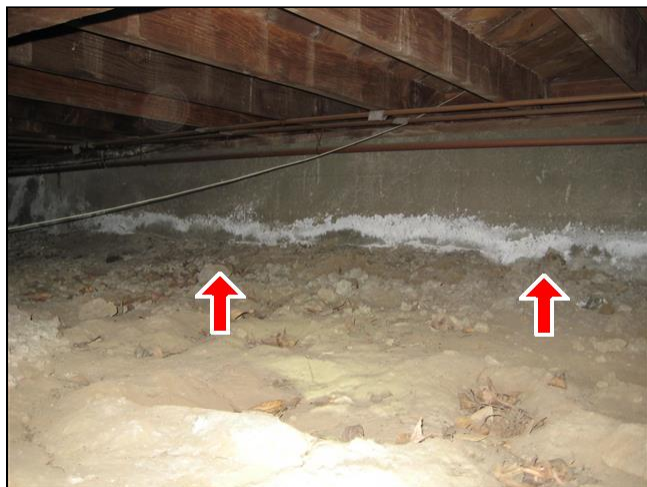
5.0 Item 1(Picture) effervescence

5.0 (1) White efflorescence (powder substance) on block wall indicates moisture is in contact with the masonry. This does not necessarily indicate that intrusion will occur. I recommend checking the gutters and the downspout drain lines for proper operation. Also, a water proofing paint could be applied to the interior side of the block if necessary. Efflorescence is found on many homes without water intrusion occurring inside the home. But, it should alert you to the possibility that future steps may be needed.

With effervescence consistent around parameter foundation walls, it suggests that a Drain Tile is not present.

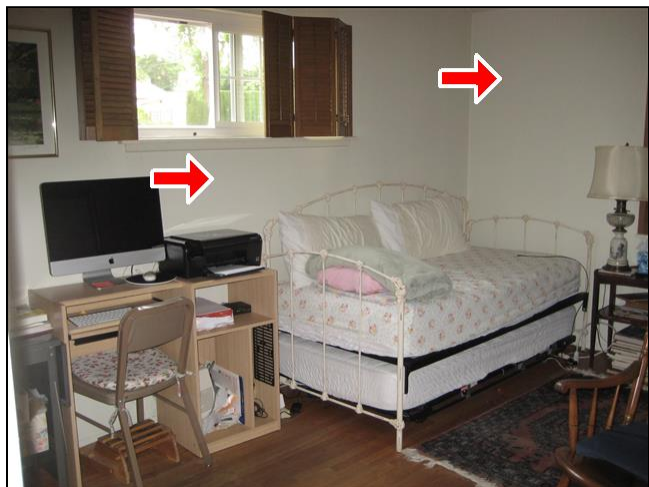
5.1 Item 1(Picture) Structural walls not visible

5.1 The wall framing on the wall was not visible at the through entire home. Could not be inspected due to wall covering.. Advise to monitor walls for new cracks or settling.

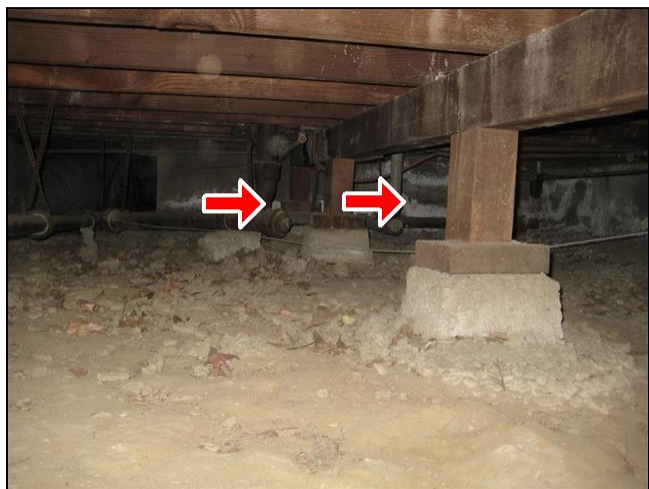
5.2 Item 1(Picture) Piers

5.2 Existing ground cover made me unable to determine if piers have proper concrete pad as an in-ground support system. Recommend further evaluation by structural engineer.

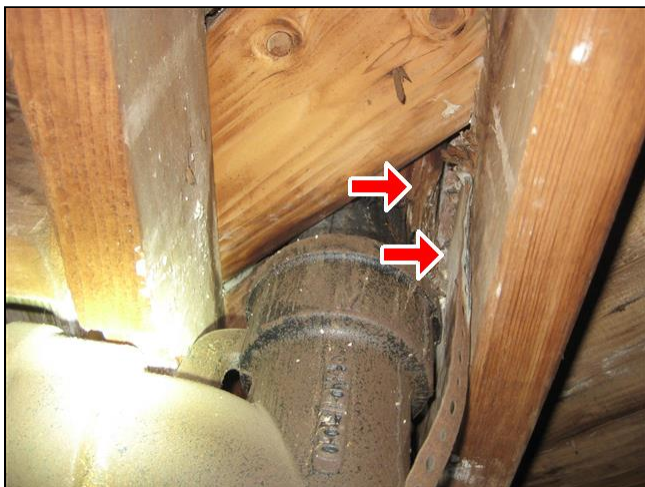
5.3 Item 1(Picture) Damage

(2) Sub-flooring and a few floor joist(s) are somewhat deteriorated from moisture or wood eating insects. Under the Master bath and Guest bath. No additional repairs are needed at this time. Refer to termite report for further evaluation and repair.

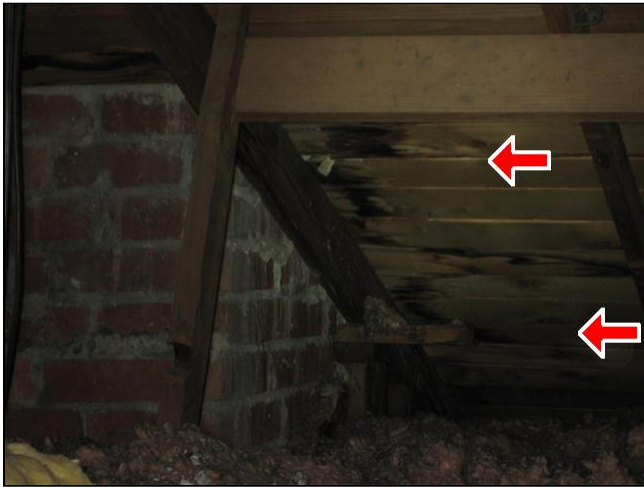
5.5 Item 1(Picture) Water penetration

(2) The roof sheathing deteriorated as a result from a leak around the chimney. Area still remains strong. It is not cost effective to replace until next roof. I recommend a qualified contractor perform the work.

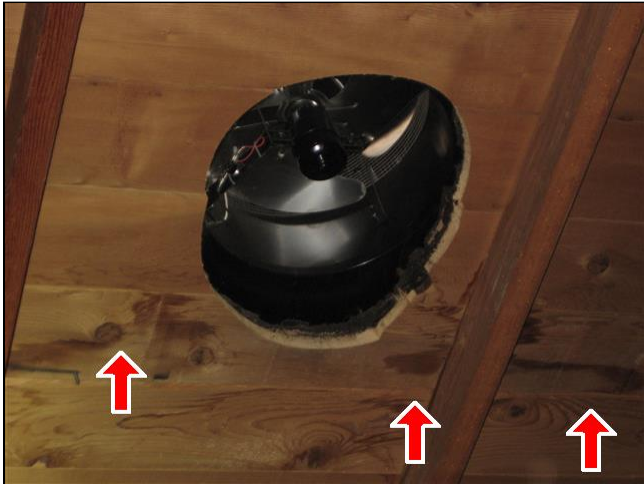
5.5 Item 2(Picture) Water stains

(3) Water signs are on plywood resulting from a roof leak found around attic exhaust fan and a vent pipe. The damage to this area is not significant to require replacing at this time. It is recommend to monitor after a heavy rain and repair if needed.

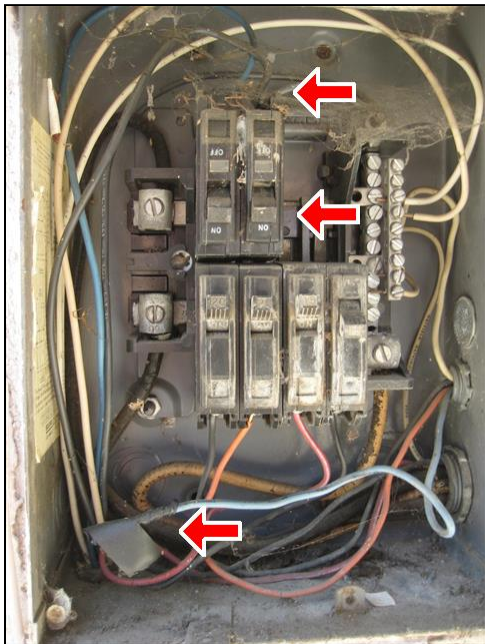
7.1 Item 4(Picture) Sub panel issues

(5) The main panel box is located at the outside on east wall. The panel is being used as a junction box. This is a safety issue that needs to be corrected. A qualified licensed electrical contractor should correct as needed.

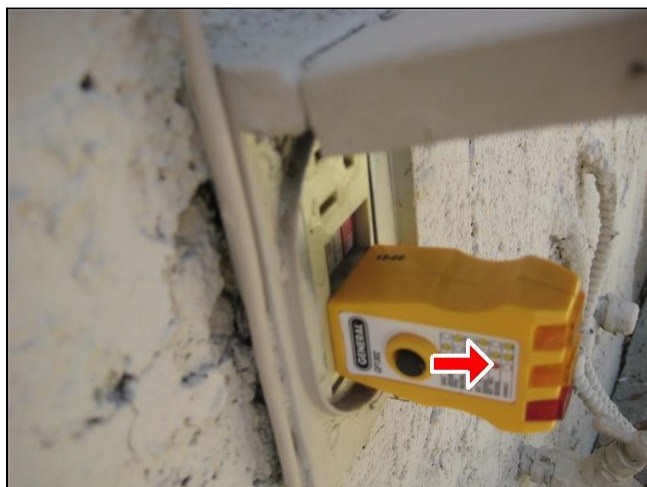
7.5 Item 1(Picture) GFCI no power

7.5 One GFCI (Ground Fault Circuit Interrupter) outlet at the outside near main panel did not work or there is no power to outlet. Further inspection is needed by a qualified licensed electrical contractor. A qualified licensed electrical contractor should perform repairs that involve wiring.

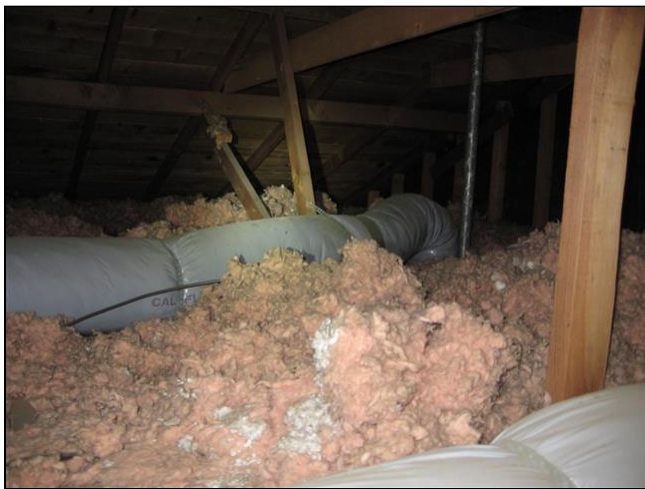
9.0 Item 1(Picture) Insulation

9.0 Difficult to tell the thickness of the insulation and therefore the R-value. Insulation was blown in and did not have a uniformity in depth. It does appear to be a minimum of 6 inches and a maximum of 15 inches.

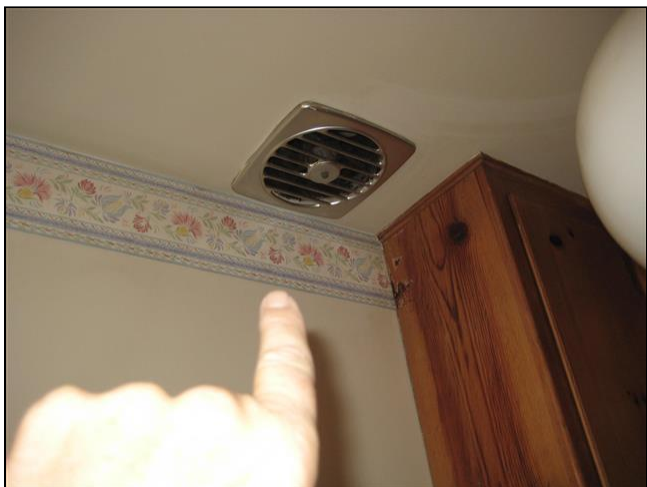
10.2 Item 1(Picture) Kitchen exhaust fan

10.2 The exhaust fan did not work when tested. I recommend repair or replace as needed.

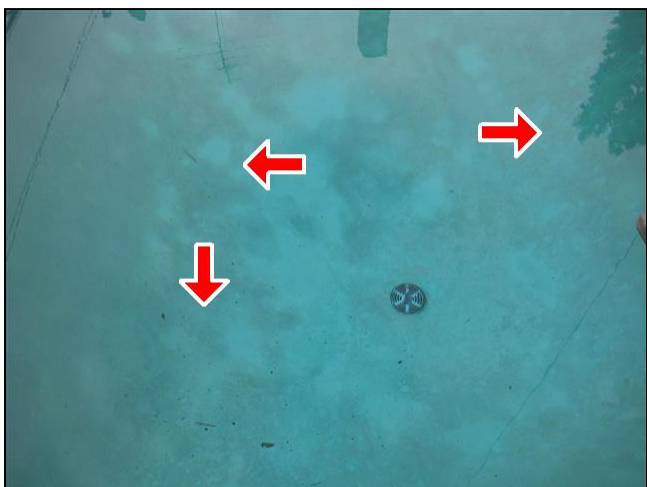
11.3 Item 1(Picture) General discoloration

11.3 Pool has discoloration in several locations. Recommend further evaluation by certified pool technician.

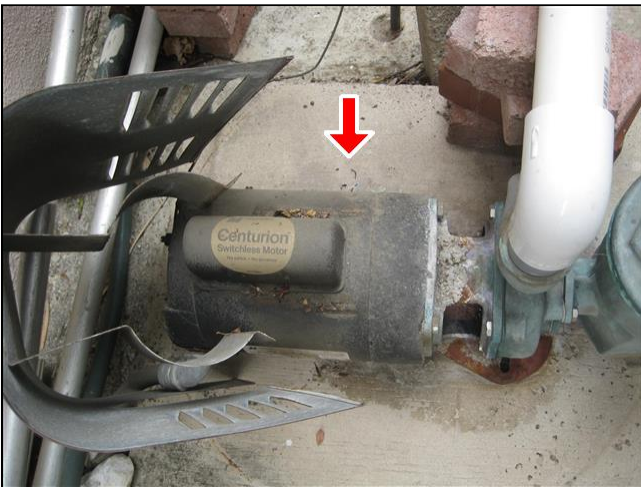
11.5 Item 1(Picture) Pool Pump

Signs of corrosion at the pool pump. Pump is functional at the time of inspection however could be nearing the end of its life.

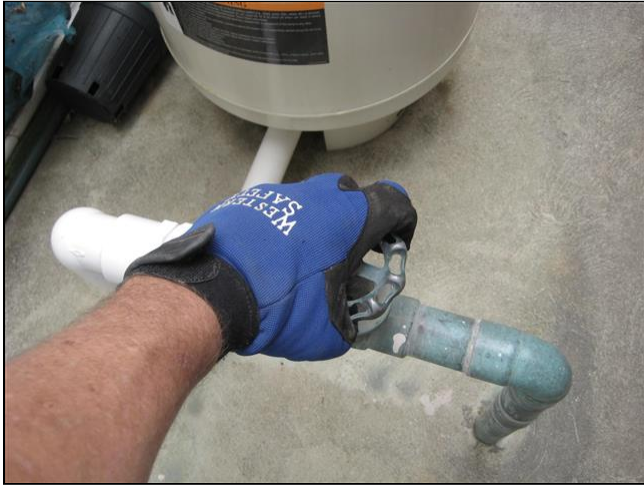
11.11 Item 1(Picture) Abandoned Pool fill valve

Original pool fill valve was not functional and abandoned. New fill valve is located at southeast corner of home.
