Inspection Report

Property Address:
5630 Ostrom Ave.

Della Mandell Residence

20/20 Vision Home Inspections, LLC

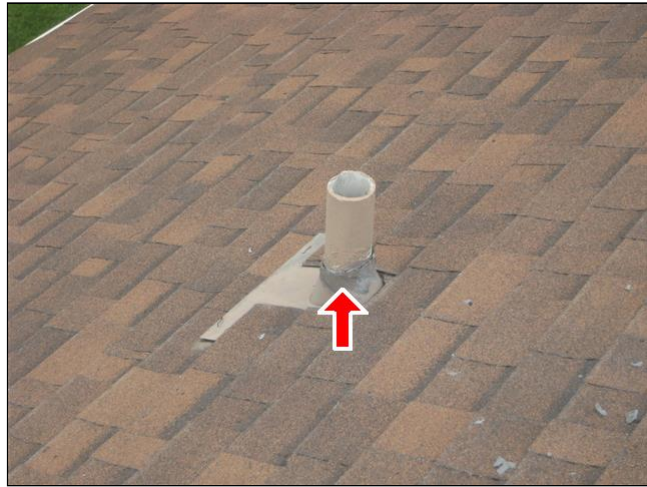
1.2 Item 1(Picture) Solar Powered motorized roof vent

Motorized roof vent installed to reduce temperature in adequately vented attic. Improper installation of flashing. Recommend further evaluation and repair by licensed roofing contractor.

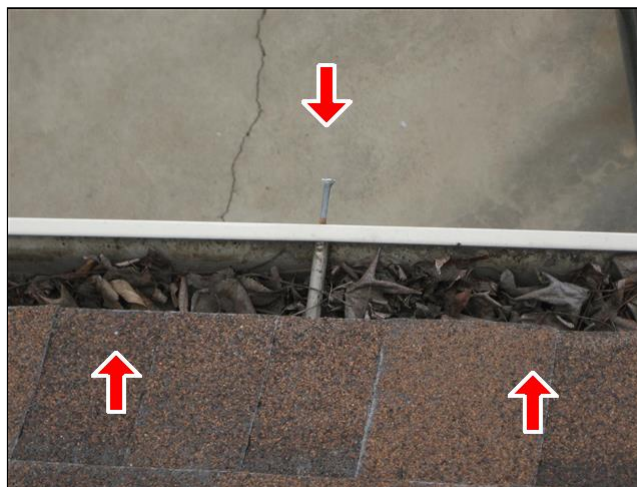
1.3 Item 2(Picture) Loose gutter

(2) The gutter is loose and needs cleaning of debris at the (West side of home) and (South side of home). Gutters that drain poorly or clogged can lead to many costly problems such as deterioration of fascia, soffit or roof edge. It can also cause gutters to pull loose and lead to possible water intrusion. A qualified person should repair or replace as needed.

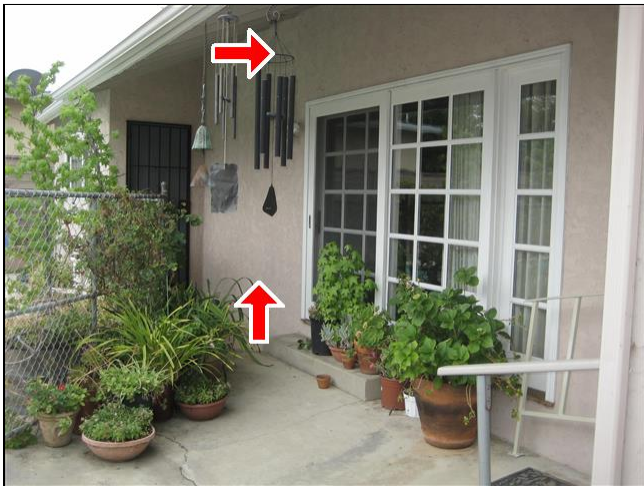
2.0 Exterior stucco and shiplap walls appear to be in good condition at the time of inspection.

2.0 Item 1(Picture) Stucco walls

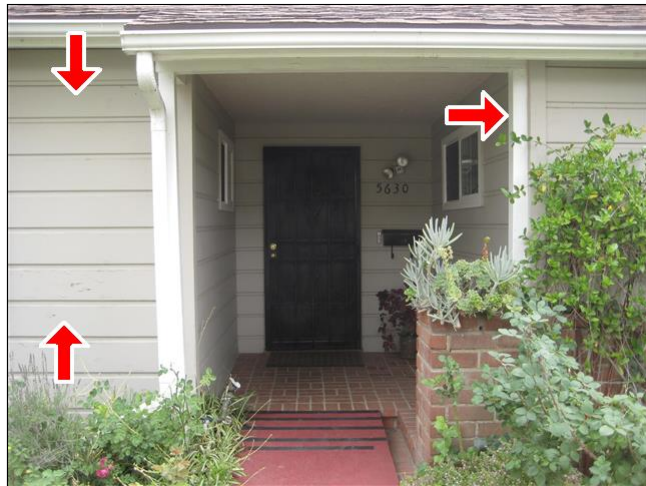
2.0 Item 2(Picture) Shiplap

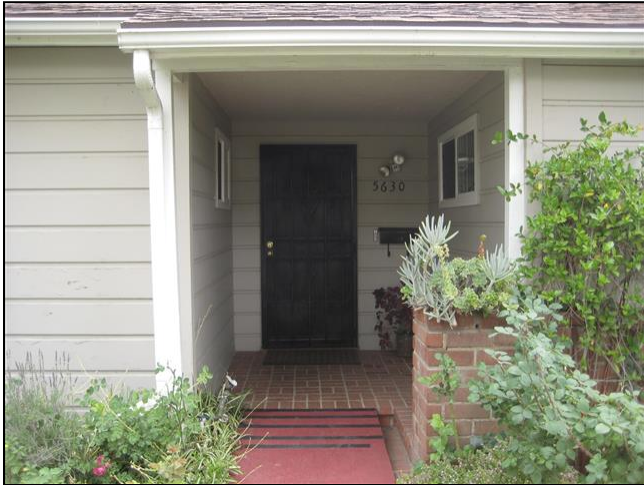
2.1 The entry doors at front and rear of home were functional at the time of the inspection. Front entry was supported by functional metal security door.

2.1 Item 1(Picture) Front Entrance

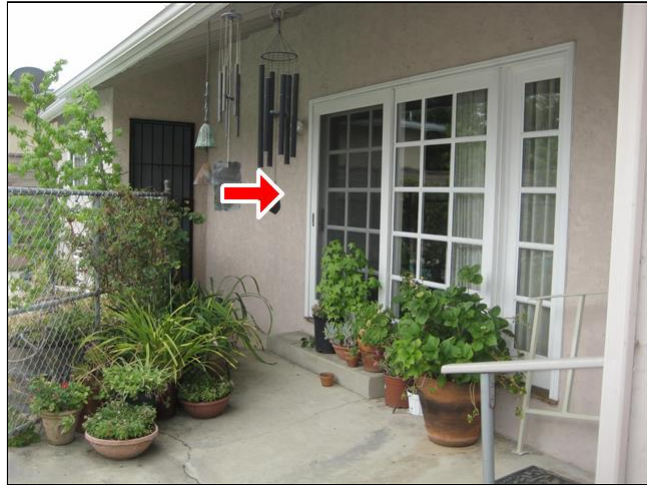
The sliding door at rear of home was functional at the time of the inspection.

2.1 Item 2(Picture) Rear sliding door

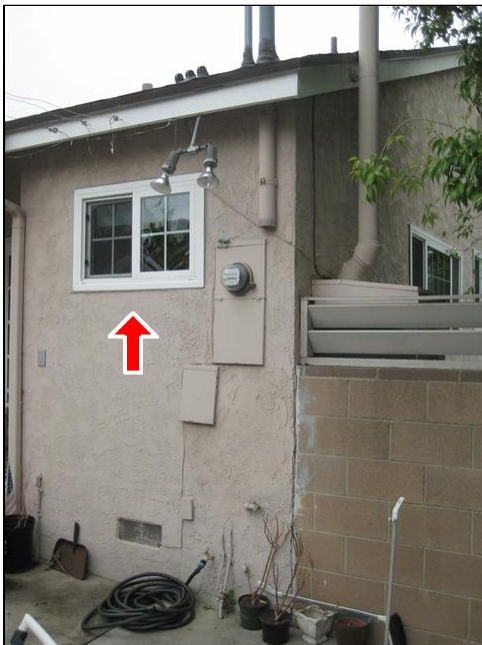
2.2 Windows were functional at the time of inspection.

2.2 Item 1(Picture) Window exterior

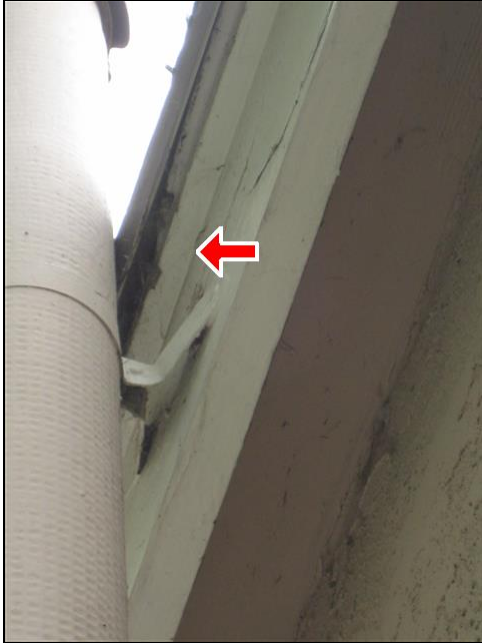
2.5 The wood fascia at eave on the (North side of home) damaged. Further deterioration may occur if not repaired. A qualified person should repair or replace as needed.

2.5 Item 1(Picture) Fascia damage

Refer to termite report for further evaluation.

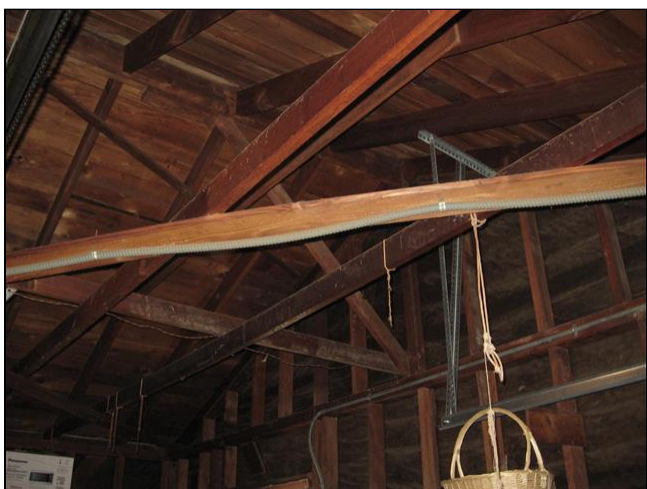
3.0 Garage ceiling was open frame and appeared to be in good condition at the time of inspection

3.0 Item 1(Picture) Garage ceiling

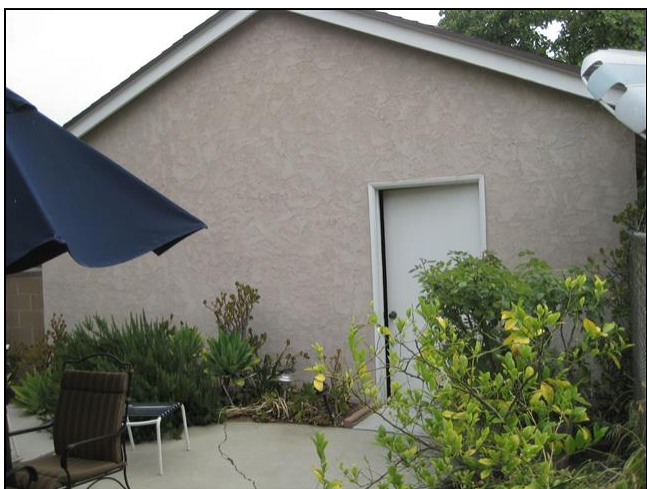
3.1 Garage was detached from home.

3.1 Item 1(Picture) Detached garage

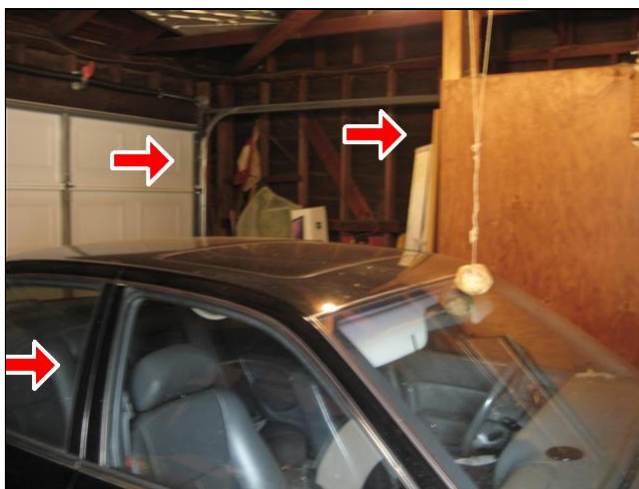
Occupants belongings block entire view of garage - unable to fully inspect. Do a careful check on your final walk through.

3.1 Item 2(Picture) Impeded view garage

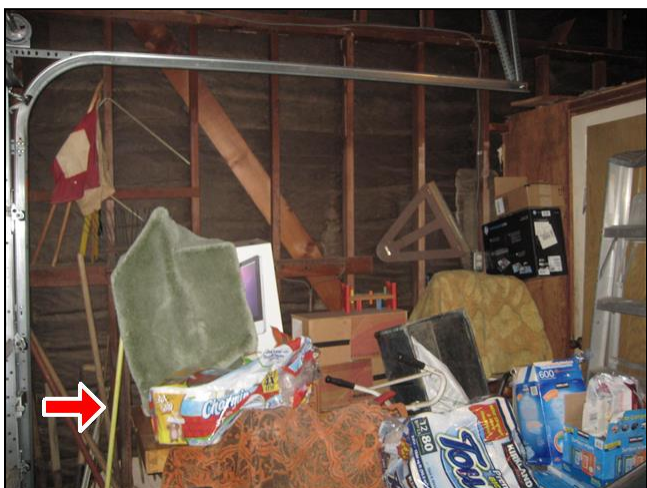
3.1 Item 3(Picture) Impeded view garage

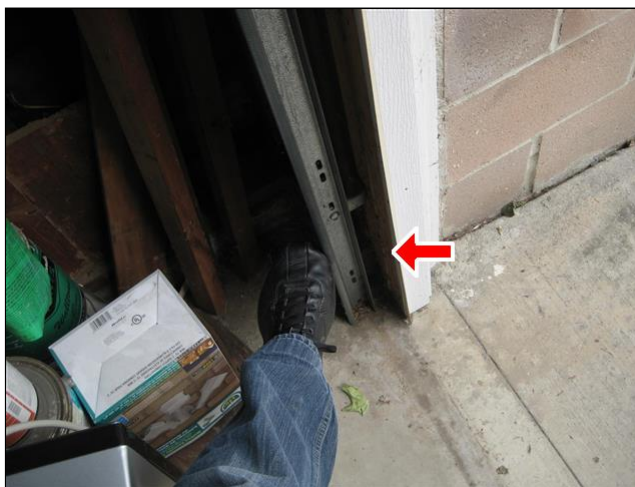
3.3 Item 2(Picture) Missing safety sensor

(2) The garage door of detached building at the (East side of home) is missing the electronic safety sensor. This is designed to prevent injury or death to people as well as animals and is required by local building code.. A qualified contractor should inspect and repair as needed.

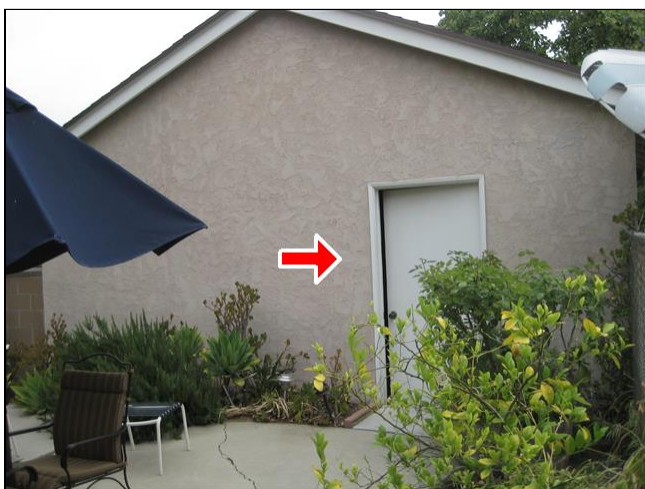
3.3 Item 3(Picture) Passage door

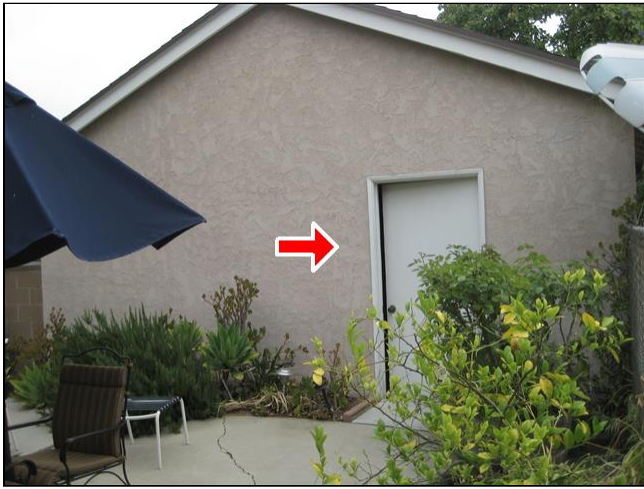
3.4 The garage door at the detached garage appeared to be functional at the time of the inspection.

3.4 Item 1(Picture) Occupant door

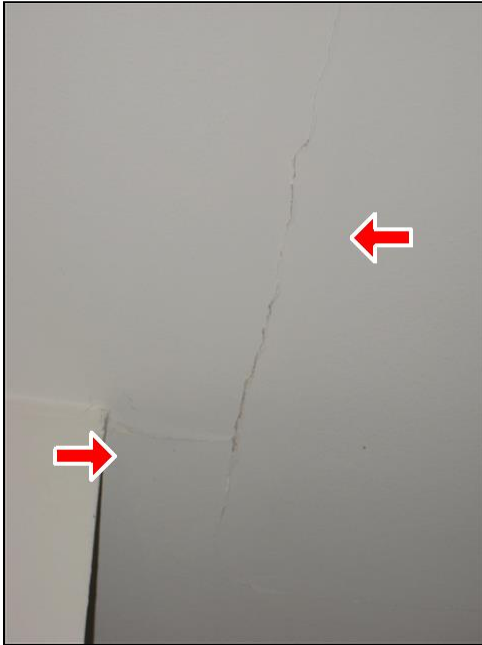
(2) The Plaster on the ceiling has multiple cracks at the through entire home. While this damage is cosmetic, it should be repaired. A qualified person should repair or replace as needed.

Homeowner stated that this occurred during 1994 earthquake and has not gotten worse since.

4.0 Item 2(Picture) Plaster damage

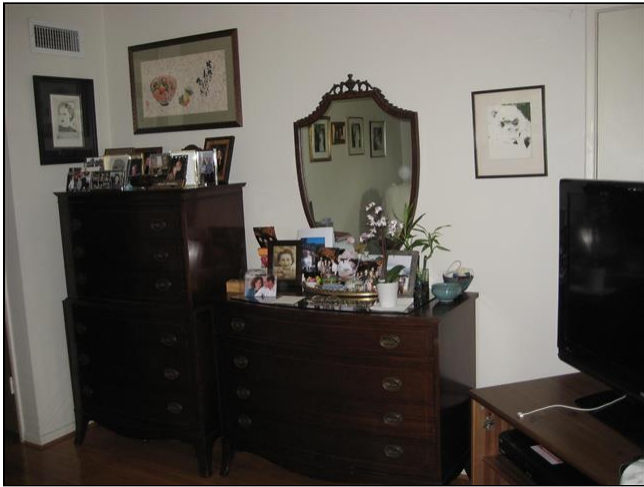
4.1 (1) The condition of walls behind wallpaper, paneling and furnishings cannot be judged.

4.1 Item 1(Picture) Personal belongings

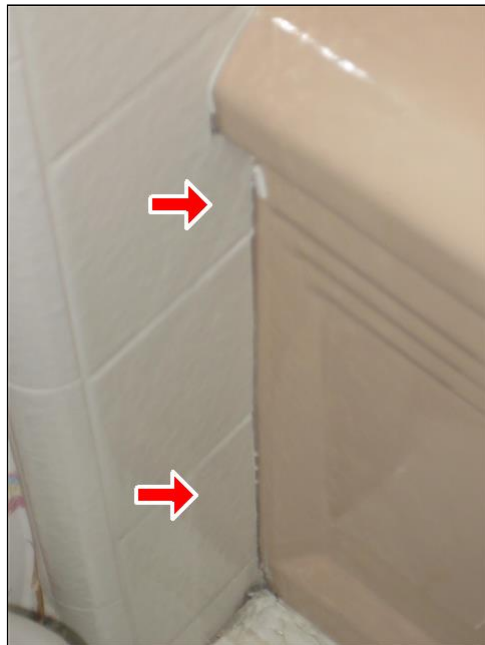
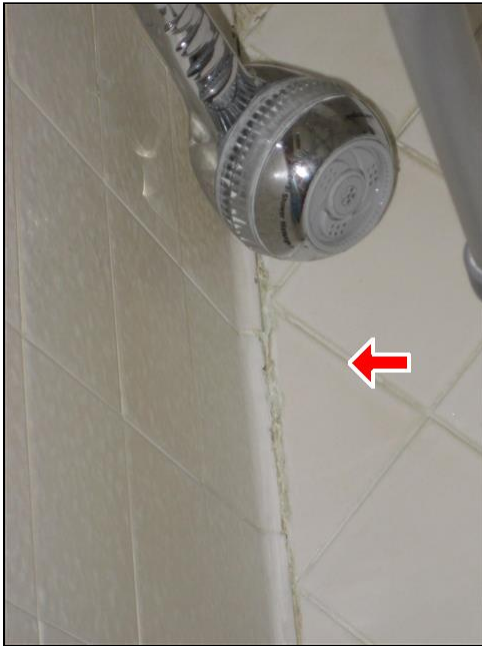
4.1 Item 4(Picture) Grout needed

(4) The tile on the wall missing grout or silicone around perimeter, where wall tile rests on tub at the master bath and guest bath. Repairs are needed to prevent water damage to shower/bath. A qualified person should repair or replace as needed.

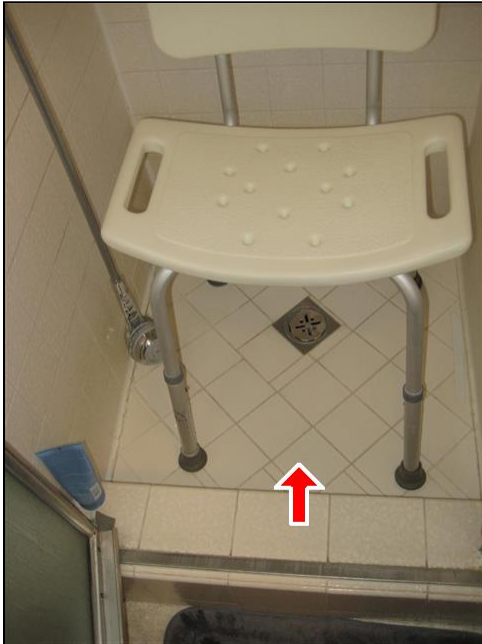
4.2 Item 1(Picture) Shower Pan

(2) Shower pan is not tested for leaks at the guest bath and master bath. This is for your information. Refer to termite report for further evaluation and repair as needed.

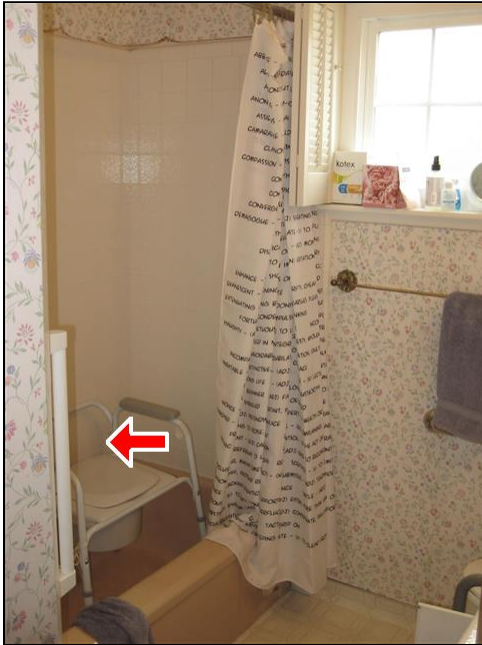
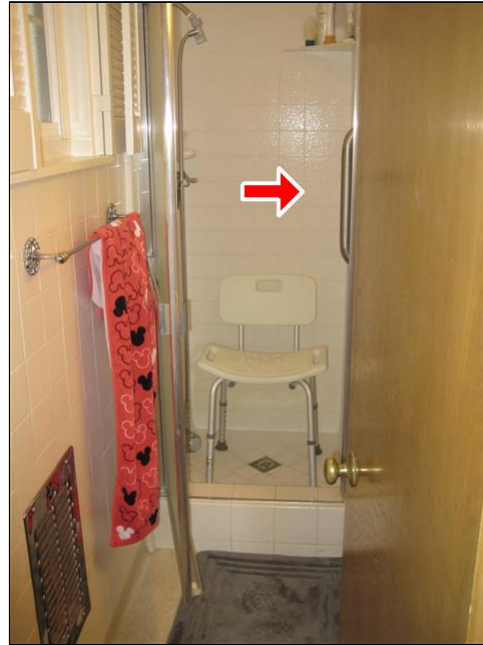
Handrails in master and guest bathrooms appear sturdy at the time of inspection. Recommend consulting ADA code for compliance.

4.3 Item 1(Picture) Handrail

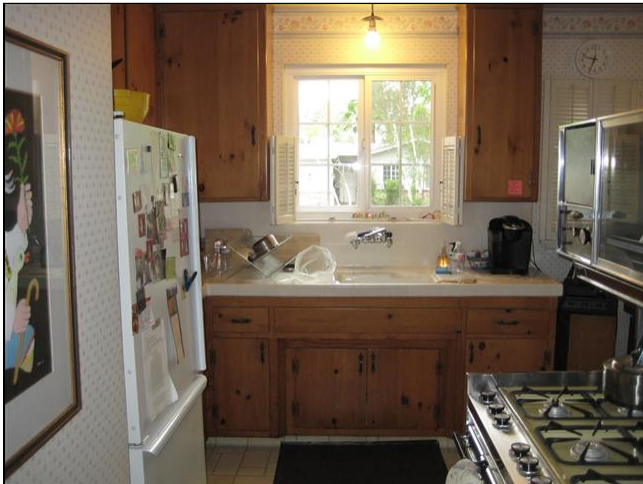
The countertops in the kitchen and bathrooms were functional at the time of the inspection. No major defects noted.

4.4 Item 1(Picture) Kitchen cabinets and counter top

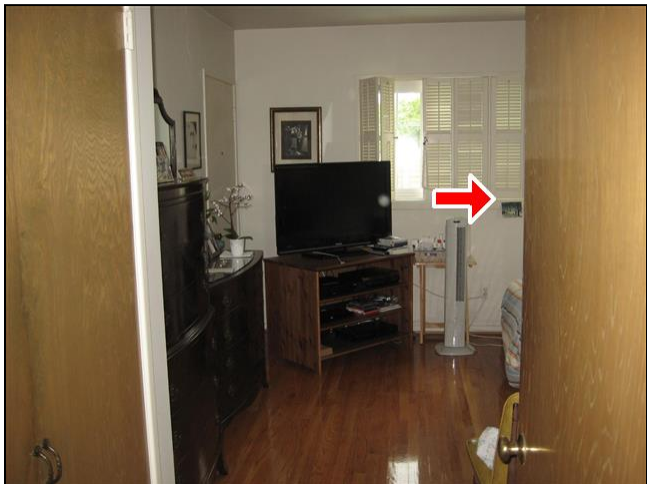
4.5 (1) The interior doors appeared functional at the through entire home with the exception on one. No deficiencies were noted at the time of the inspection.

4.5 Item 1(Picture) Interior doors

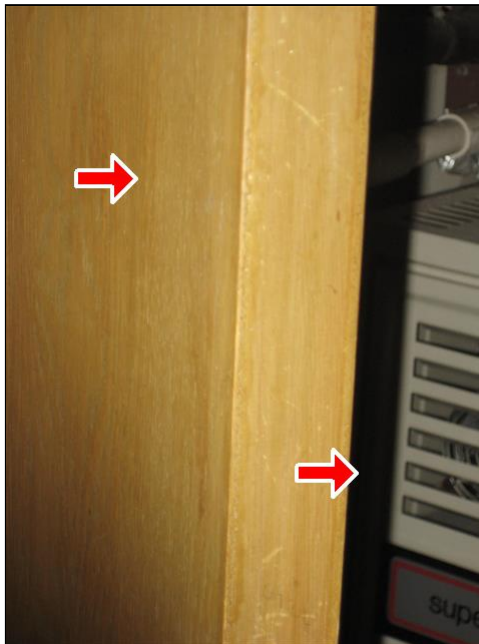
4.5 Item 2(Picture) Improper door

(2) The Closet door should be replaced by louvered door at the furnace. The existing door does not allow for air flow to be properly supplied to the furnace.. A qualified person should replace as needed.

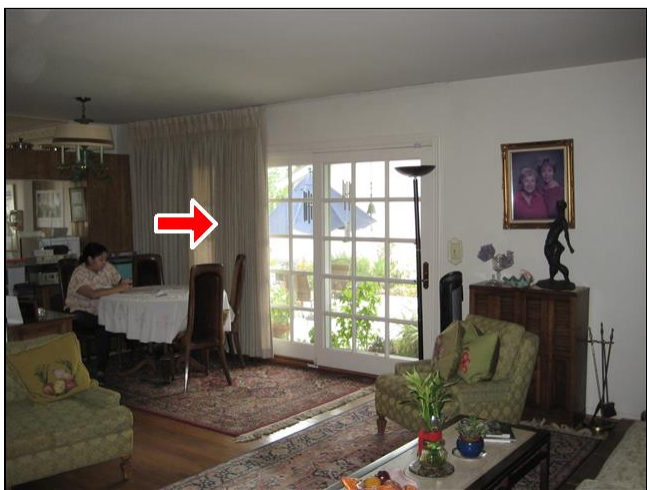
4.6 Item 1(Picture)

(2) All windows appeared functional at the through entire home. Monitor for changes.. No action needed..

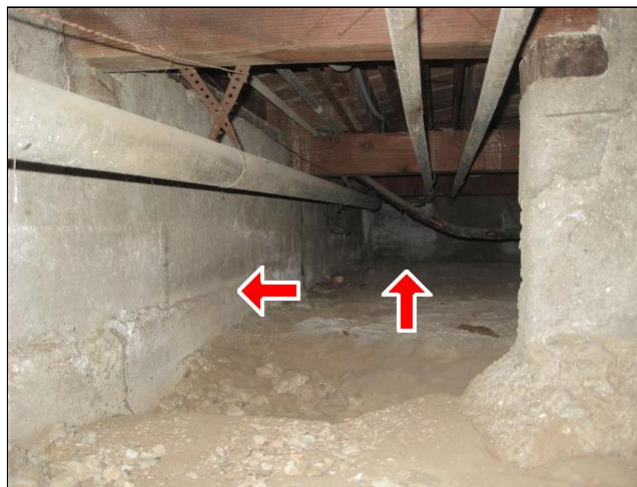
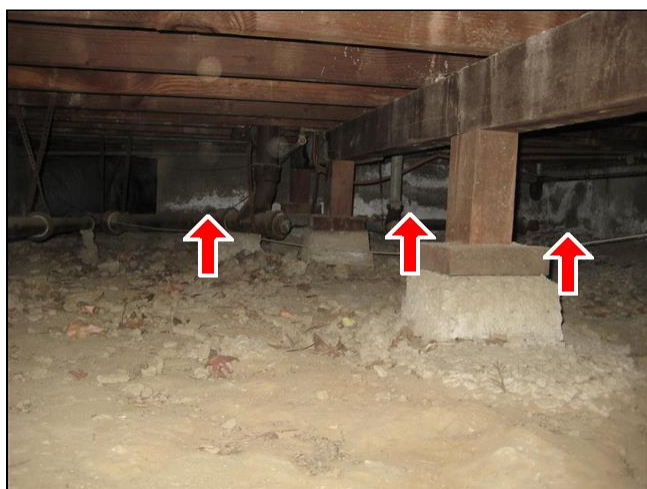
5.0 (1) White efflorescence (powder substance) on block wall indicates moisture is in contact with the masonry. This does not necessarily indicate that intrusion will occur. I recommend checking the gutters and the downspout drain lines for proper operation. Also, a water proofing paint could be applied to the interior side of the block if necessary. Efflorescence is found on many homes without water intrusion occurring inside the home. But, it should alert you to the possibility that future steps may be needed.

With effervescence consistent around parameter foundation walls, it suggests that a Drain Tile is not present.

5.0 Item 2(Picture) effervescence

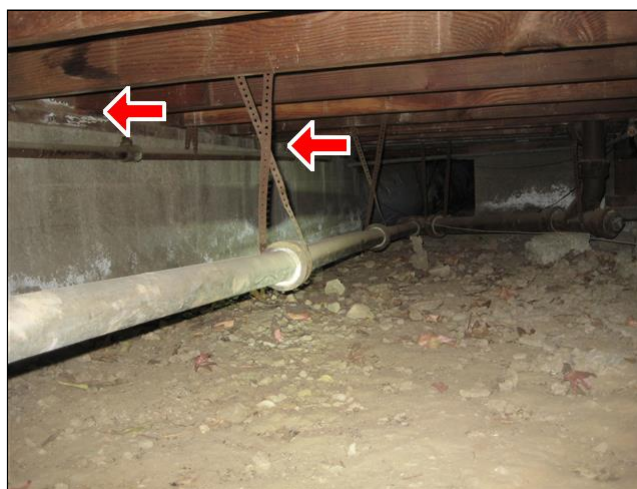
5.0 Item 4(Picture) No anchor bolts

(3) The foundation wall and the bearing walls do not appear to be connected through an anchoring system. . Walls may need to be anchored to foundation. A qualified engineer should inspect and repair or replace as needed.

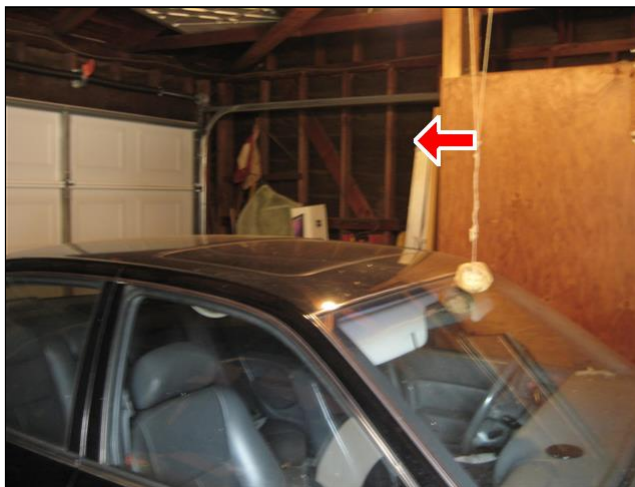
5.1 The wall framing on the wall was not visible at the through entire home. Could not be inspected due to wall covering.. Advise to monitor walls for new cracks or settling.

5.1 Item 2(Picture) 2 X 4 construction

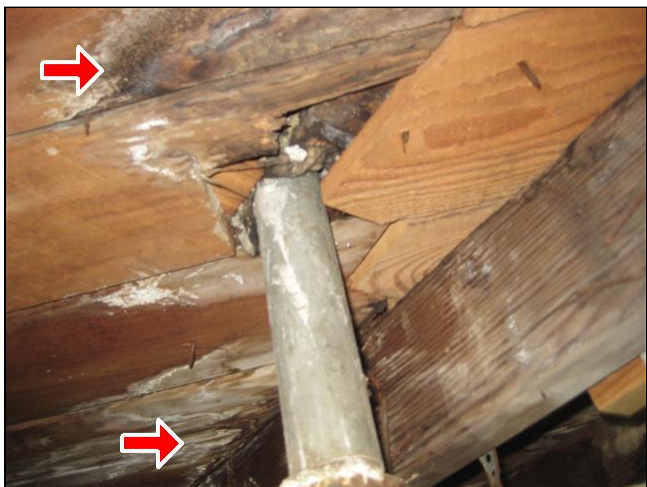
(2) Sub-flooring and a few floor joist(s) are somewhat deteriorated from moisture or wood eating insects. Under the Master bath and Guest bath. No additional repairs are needed at this time. Refer to termite report for further evaluation and repair.

Shower pans are not tested or inspected as they are beyond the scope of this inspection. Please refer to termite report for further evaluation.

5.3 Item 2(Picture) Guest bath Shower

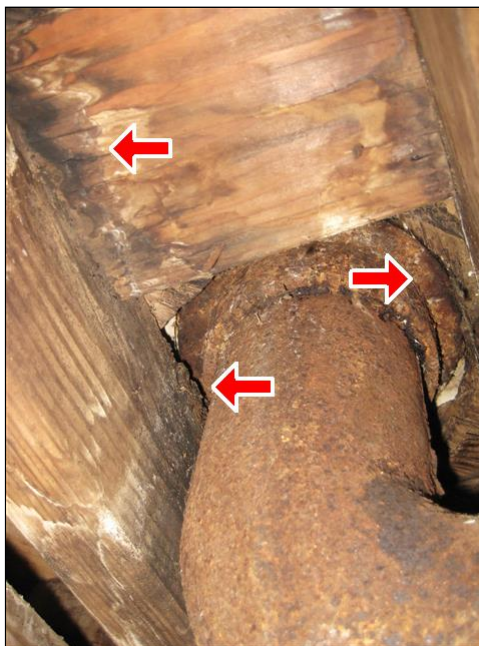
5.3 Item 3(Picture) Master Bathroom Toilet

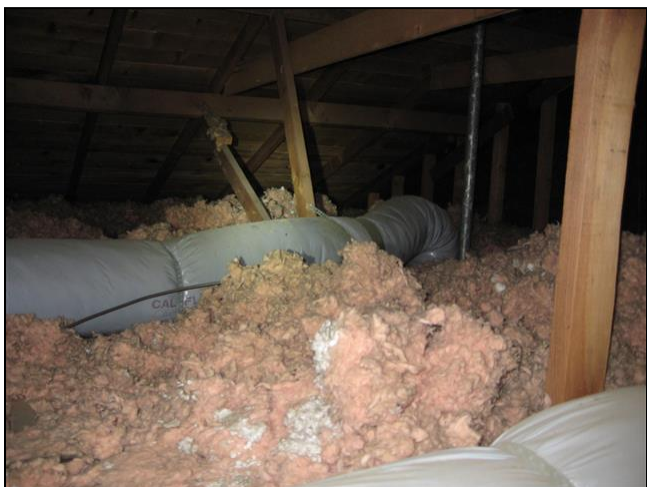
5.4 Blown insulation prevented inspector from inspecting ceiling structure.

5.4 Item 1(Picture) Cannot see ceiling structure

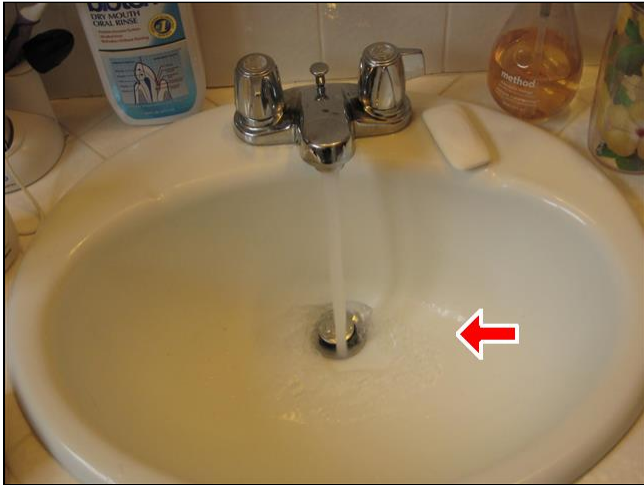
All drain, waste and venting appeared functional at the time of inspection. No deficiencies were noted.

6.0 Item 1(Picture) Non restricted drain

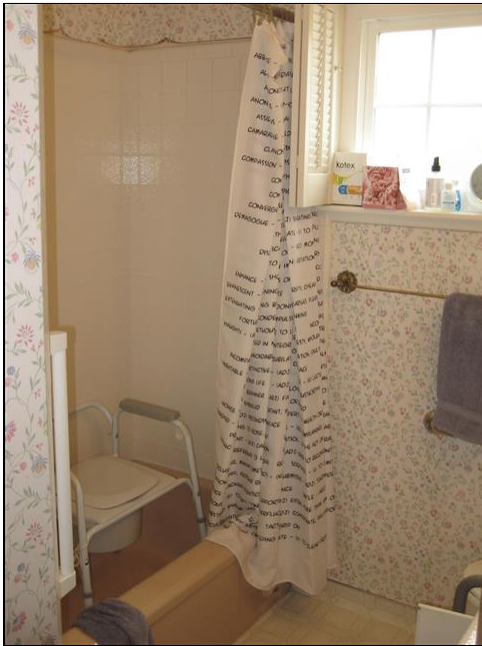
All plumbing fixtures throughout home were functional at the time of the inspection.

6.1 Item 1(Picture) Master Shower

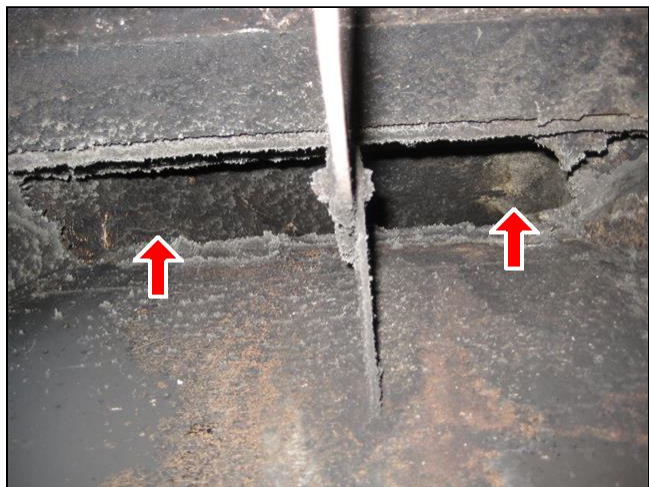
Chimney was not operating at the time of inspection. However, creosote was noted and it is recommended that the chimney be serviced by qualified chimney contactor.

6.2 Item 1(Picture) Creosote

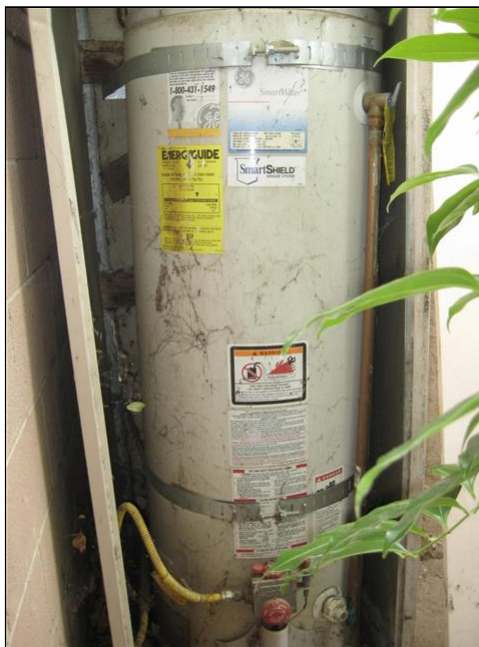
Hot water heater is manufactured in 2006 and may be nearing the end of its functional life. However at the time of inspection, it appeared to be functional.

6.2 Item 2(Picture) Hot Water Heater

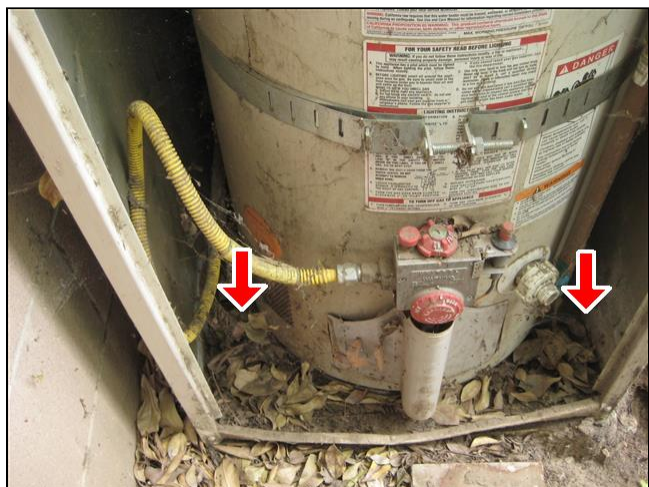
6.2 Item 3(Picture) Debris

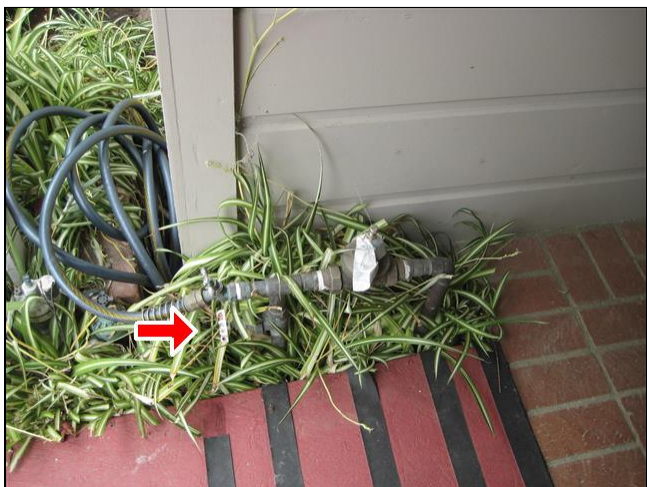
6.3 The main shut off is the red knob located outside near the front door. This is for your information.

6.3 Item 1(Picture) Main water shutoff

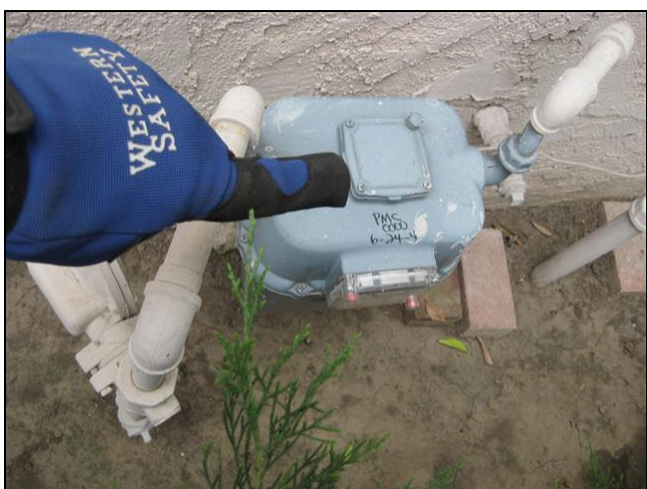
6.5 Item 1(Picture) Missing earthquake valve

(2) It is recommended that an earthquake valve be installed for safety.

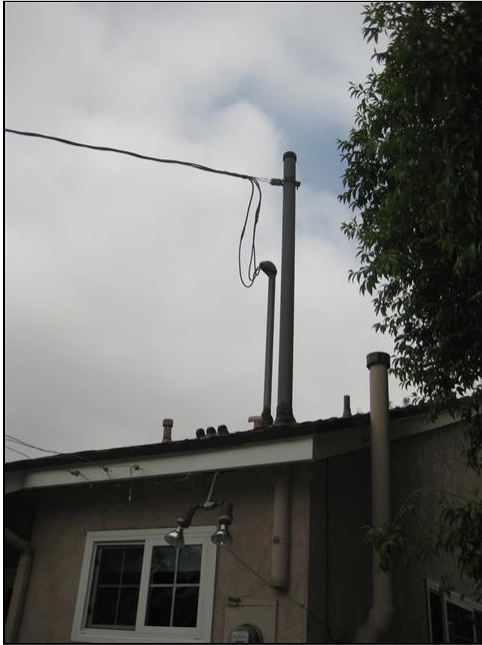
7.0 Item 1(Picture) Service entrance

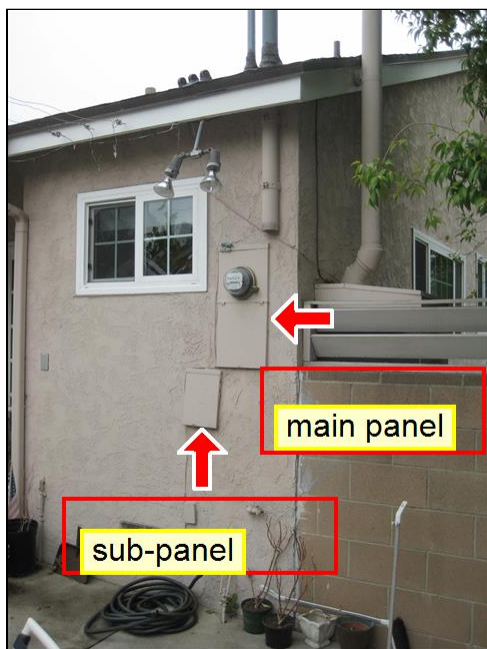
7.1 Item 1(Picture)

7.1 (1) The main panel is not properly labeled. Recommend accurate label.

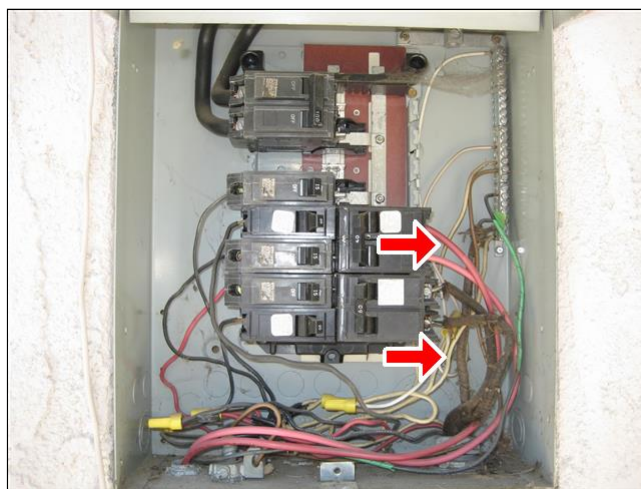
7.1 Item 2(Picture)

(2) The sub-panel is not properly labeled. Recommend accurate labeling.

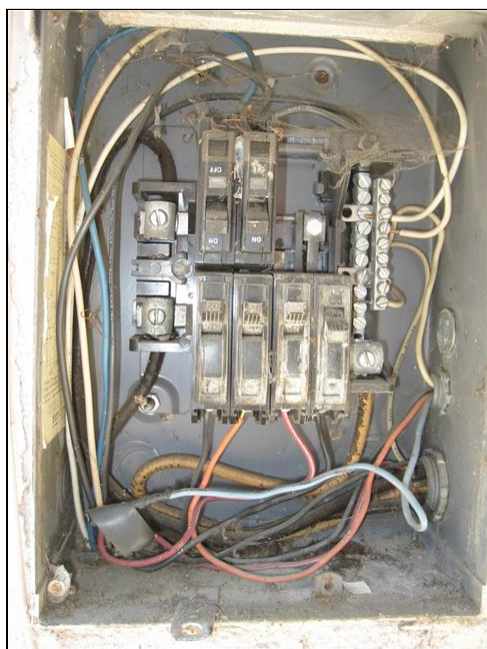
7.1 Item 3(Picture)

(4) The main panel box is located at the outside on east wall. The panel has some fraying wiring. This could pose a problem if the condition is not addressed. A qualified licensed electrical contractor should correct as needed.

(6) The sub-panel box is located at the outside on east wall. The panel has breakers that are double tapped. This is a safety issue that needs to be corrected. A qualified licensed electrical contractor should perform repairs that involve wiring.

(7) The problem(s) discovered in the panel such as doubled wiring at circuit(s), and any other problems that an electrical contractor may discover while performing repairs need correcting. I recommend a licensed electrical contractor inspect further and correct as needed.

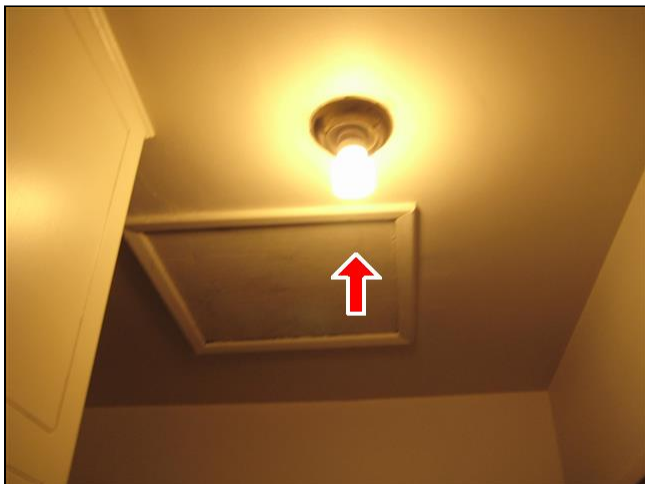
7.3 (1) The light fixture is missing globe at the through entire home. Exposed bulbs can be easily broken and cause injury.. I recommend repair as needed.

7.3 Item 1(Picture) Missing bulb cover

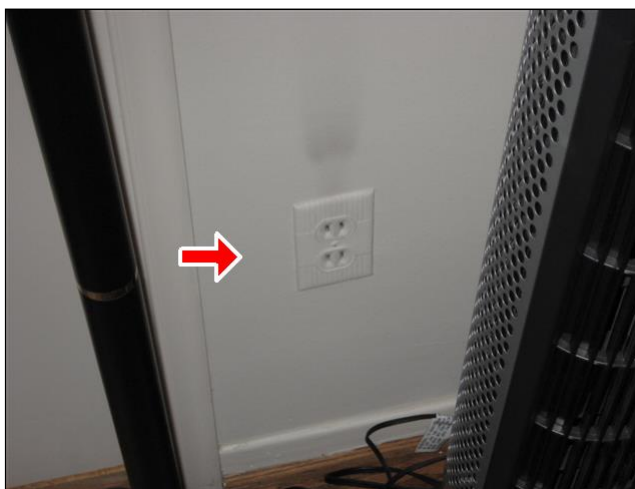
7.3 Item 4(Picture) non grounded outlet

(2) "two-prong" outlets are not grounded in the hallway and (left of hall bath). (right of hall bath) in the formal living room. in the dining room. Electrical issues are considered a hazard until repaired. A qualified licensed electrical contractor should perform repairs that involve wiring.

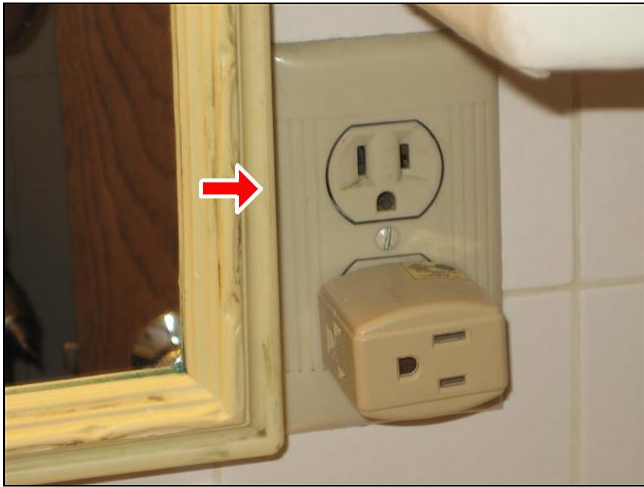
(3) "three-prong" outlets are outdated and not a three-prong GFCI (Ground Fault Circuit Interrupt) in the kitchen. in the guest bath and in the master bath. Electrical issues are considered a hazard until repaired. A qualified licensed electrical contractor should perform repairs that involve wiring.

7.4 Item 1(Picture) Bathroom outlets

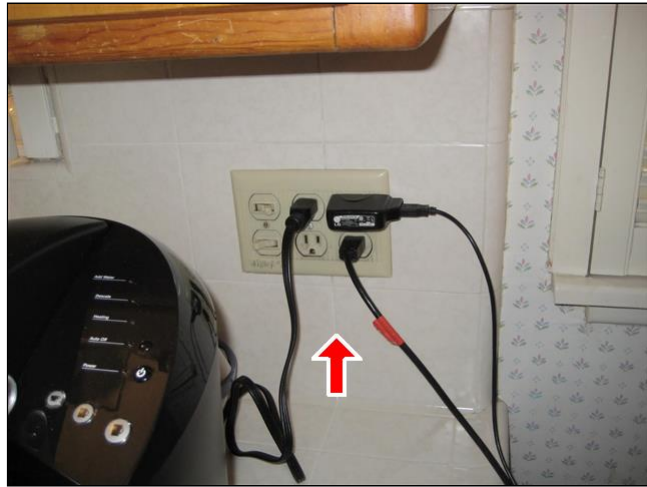
7.4 Item 2(Picture) Kitchen Outlets

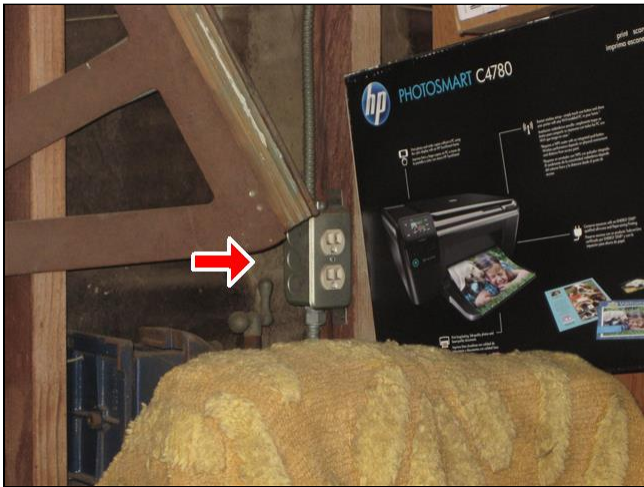
7.4 The exterior outlet at the Garage is a "two-prong" receptacle, and is not a "three-prong" GFCI outlet with exterior cover is a three prong receptacle but not a GFCI three prong receptacle nor labeled as GFCI protected. This is a safety hazard. A qualified licensed electrical contractor should perform repairs that involve wiring.

7.4 Item 3(Picture) Garage Outlets

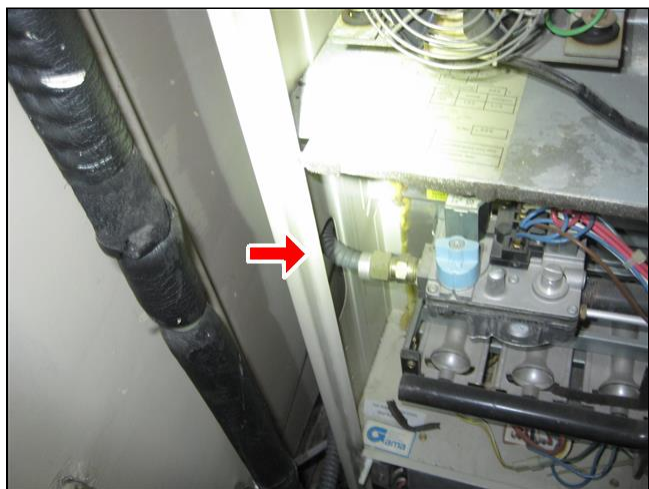
Gas line must remain rigid from point of connection until exiting from then jacket surrounding the heating unit. It can then connect with approved flexible gas line. Recommend further evaluation and replace or repair by licensed HVAC contractor.

8.3 Item 1(Picture) Flexible gas line

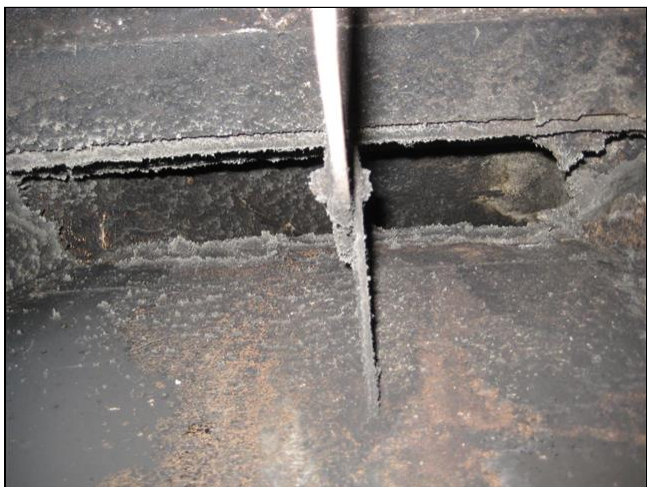
8.5 The liner was mainly visible and appears good except for creosote dust that may conceal a hairline crack until cleaned and inspected by a licensed chimney sweep. For a detailed inspection of liner, I recommend a qualified chimney sweep inspect for safety.

8.5 Item 1(Picture) Interior fireplace

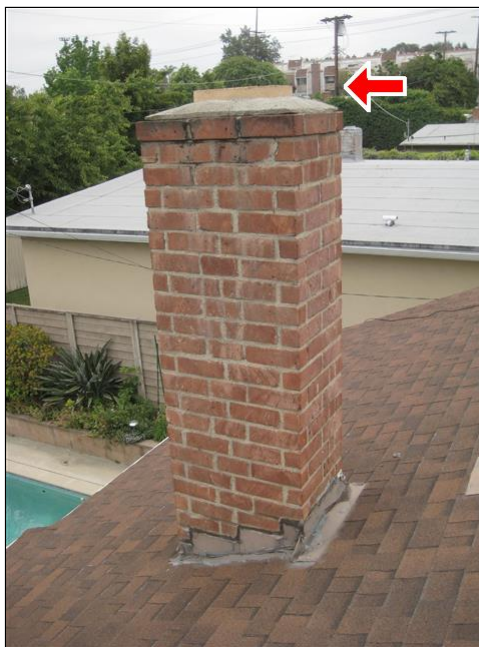
Metal rain cap on chimney crown is missing. Recommend further evaluation and repair by certified chimney contractor.

8.5 Item 2(Picture) Missing cap and arrestor

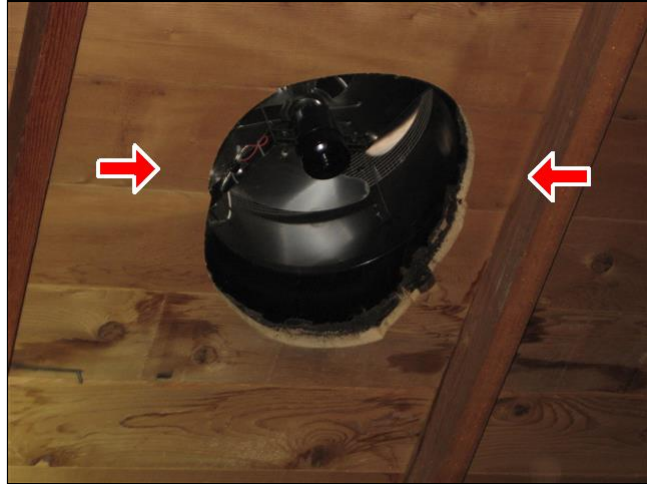
9.3 Gable end vents were insufficient to adequately regulate the attic temperature. A solar powered thermostat controlled attic vent was installed and it assisted in controlling attic temperature. Recommend owner to monitor and add another unit if needed.

9.3 Item 2(Picture) Solar Thermostat attic vent

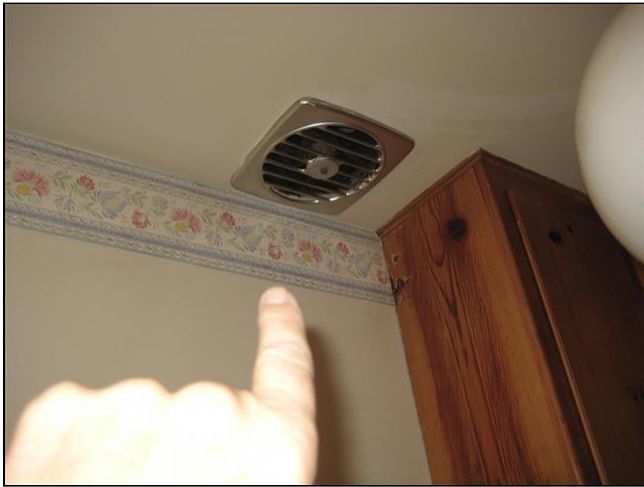
9.4 The Exhaust fan did not respond to controls at the kitchen. This could be a safety hazard if proper venting is not in place. Otherwise, the nearby kitchen window must be kept open while stove and oven are in use.. A qualified contractor should inspect and repair as needed.

9.4 Item 1(Picture) Non working kitchen Exhaust

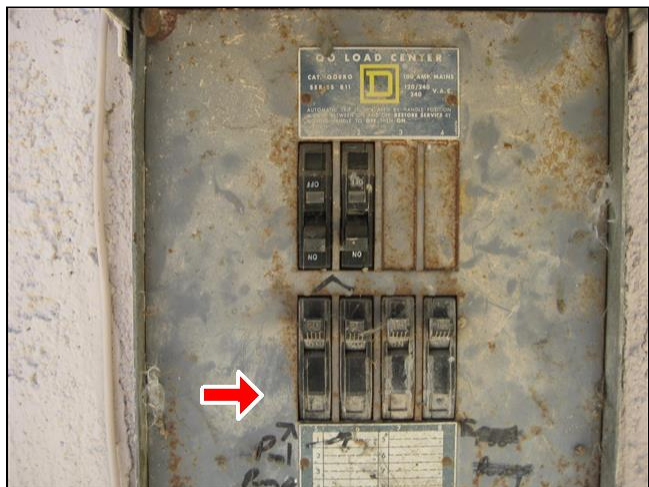
11.9 Item 1(Picture) Imporper pool equipment breaker 11.9 Item 2(Picture)

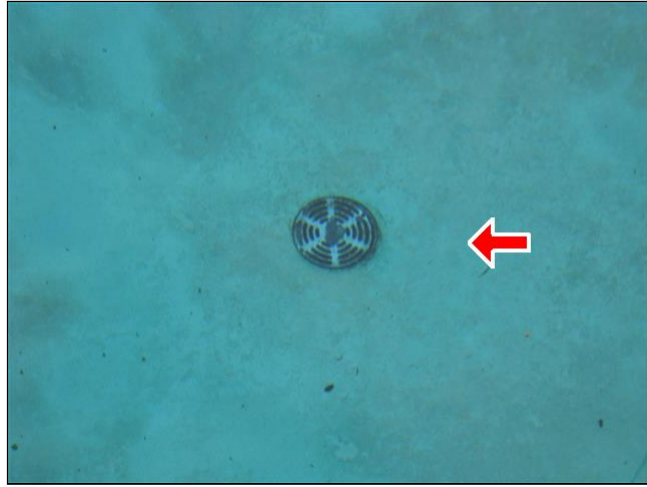
11.11 Item 2(Picture) Improper drain cover

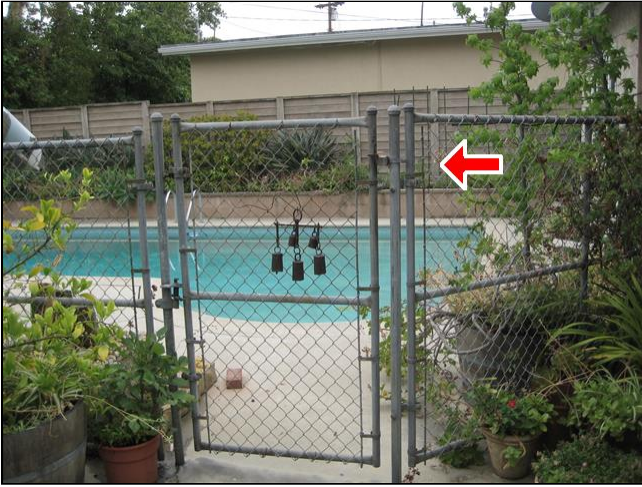
11.21 Self closing device works. However, the door opens in the wrong direction and needs to be reversed.

11.21 Item 1(Picture) Pool gate reversed
